# RESTORING AN ANCIENT EVINRUDE

## Chapter 3 – Gear-foot Reclamation

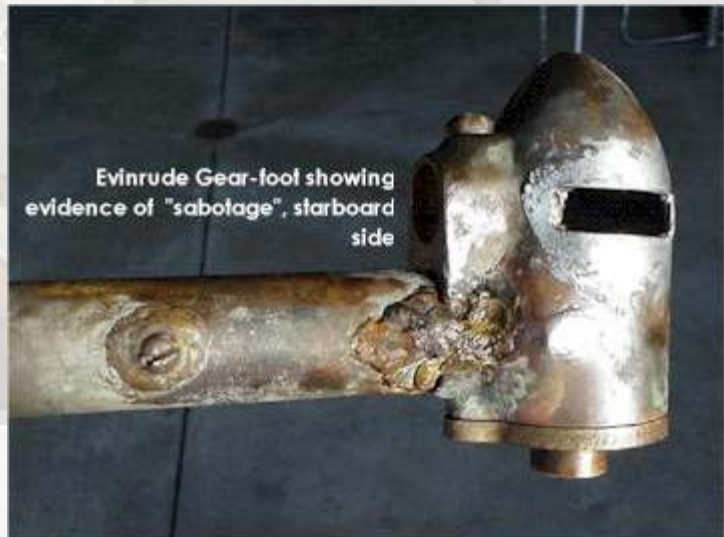
Applying heat from a propane torch was enough to melt off the solder and uncover a patch that had been applied over an access window that had been cut into the starboard side of the gear-foot casting. The only logical explanation for such butchery was that possibly the setscrew for the prop-shaft pinion had become seized or broken, and the window had to be cut to facilitate removal. A tin patch was laid over the hole and soldered in place in an attempt to seal up the hole. I don't think it was a factory-authorized fix-it job, but it wasn't something to give up on. The decision was made that the parts were salvageable, so the task was undertaken to attempt to correct the previous "repairs".

Evinrude Gear-foot showing evidence of "sabotage", starboard side

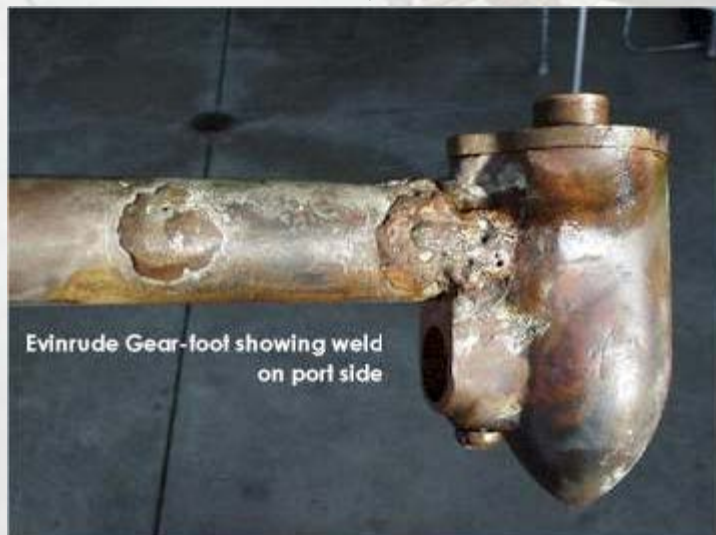
The braze buildup that was used to lock the four screws that fastened the gear-foot to the drive-shaft tube was ground off close to the outside diameter of the tube, thus removing the screw heads which were buried in the brass weld, then the screw sections that were remaining got slots cut in them with

Evinrude Gear-foot showing weld on port side

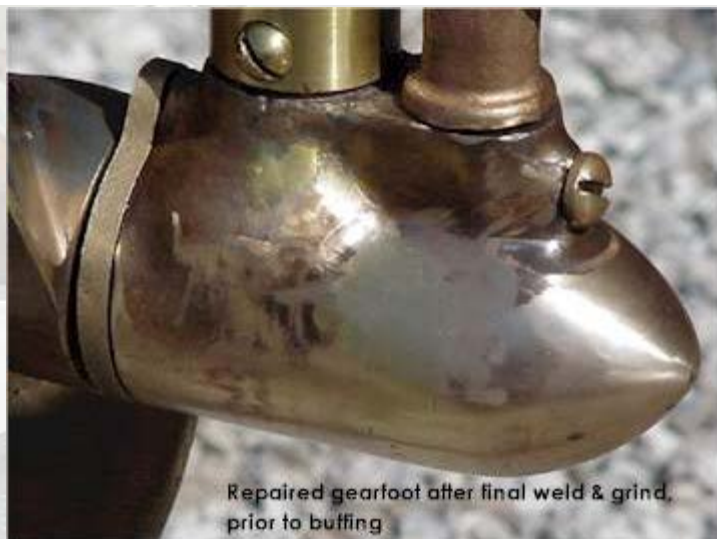
Repaired gearfoot after final weld & grind, prior to buffing

satisfied with the puddle formation, and so the weld repair proceeded. Fortunately, the torch did not "pop" on me, thereby sparing the frustration of having a weld puddle spatter all over the place with the resulting gross porosity that almost always is the end result of such an event. When the welding was finished, the part was allowed to air-cool until it could be safely handled, then the excess brass was sanded off using the belt sander to the point that a hand-grinder could finish the rough profiling. The hand-grinder was followed by wet-sanding with 600 grit paper, then the repair site was surveyed, and a decision made to further attempt to fix up some of the pinholes in the weld. The second welding attempt would be the last, one way or another. Well, maybe NOT the last; maybe just the second of many. I suppose I was being too fussy, and ended up doing a lot more remedial welding and grinding than was originally planned to plug pinholes that kept popping open, but finally got a result that was considered as acceptable.
