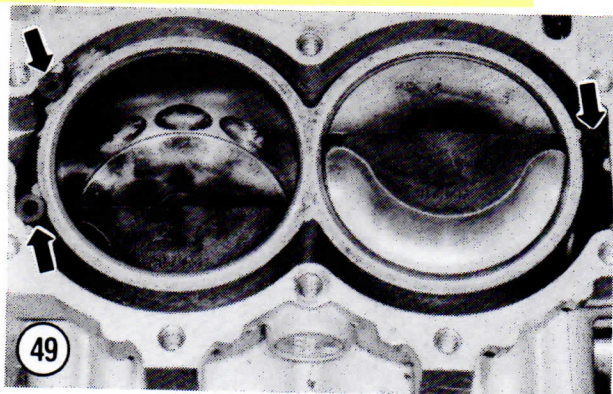
6. Check all oil and water passages in the block and cover for obstructions. Make sure any plugs installed are properly tightened.
7. Make sure all water passage restrictors (Figure 49) are in good condition and properly installed. Figure 50 shows V4 restrictor location and water circulation. Damaged, loose or missing restrictors will interfere with cooling water circulation and result in possible engine overheating.
