RESTORING AN ANCIENT EVINRUDE

Chapter 2 – Refurbishing the Power-head

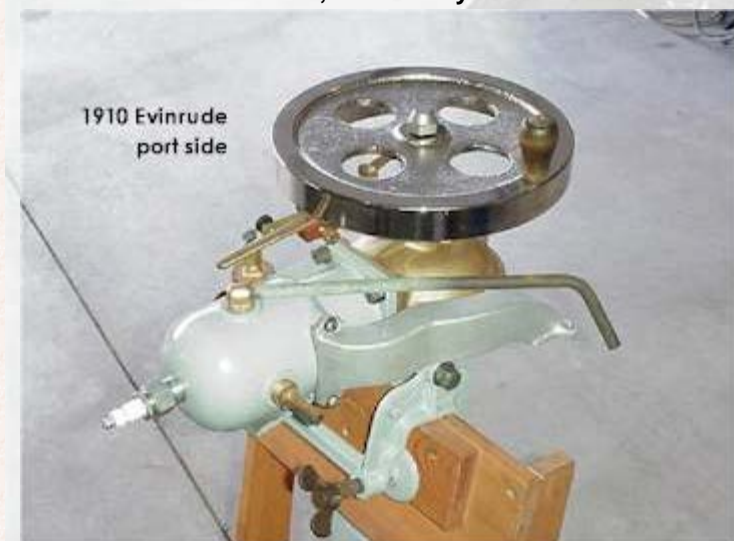
Well, one has to start somewhere, so out come the tools; but before I disassemble anything, it was decided to try and run the motor again with my own buzz-coil set-up. Its been awhile since I used a buzz-coil to fire a motor, but luckily there was a hand-drawn schematic taped to the coil so it was

easier to remember which wires were hooked to which terminals. After hunting down a 6-volt battery with some juice left in it, the appropriate connections were made, and some fuel added to the tank. Set the timer, bounce the flywheel a few times to prime, turn on the power and bounce the flywheel against the compression. POW!!! Off she goes, popping away to beat the band. I adjust the carb to smooth it out, and let her run for about 10 or 12 seconds, then kill the juice, and the motor stops. Now I'm all tingly again. I never have this much fun on the Polaris.

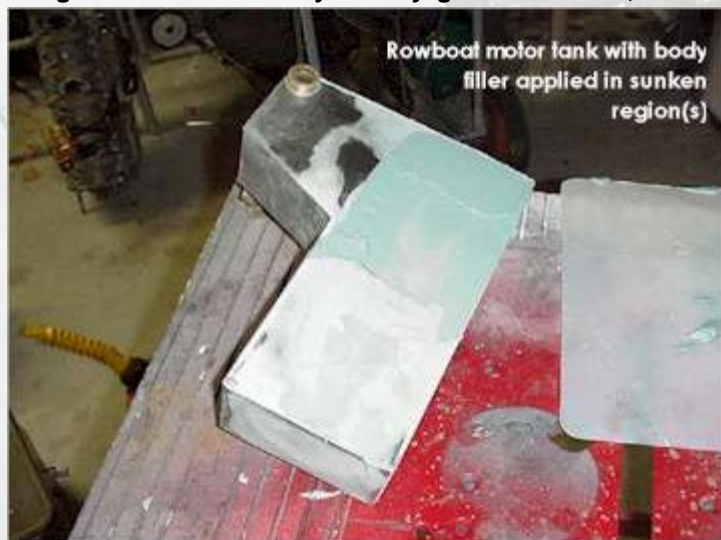
The gas tank was the final piece of the power-head that I had left. Oh, there was still an exhaust can to construct, fasteners to clean up & re-finish, and thumbscrews to figure out, but that's another story. The gas tank was actually in very good condition, all things considered. Not perfect, but it was not

rusty and it did not leak. Nonetheless, it still required a fair amount of handwork to make it look more presentable. Some of the bracket legs were coming unsoldered from the underside of the tank, so there was that detail to attend to. I used some acid to clean around the bracket, then utilized a copper iron heated with a propane torch to supply localized heat to re-solder the bracket legs. You have to be very careful with the heat when soldering the bracket. You do not want to heat the tank seams themselves if you don't have to. Terrible things can happen to a formerly leak-proof Detachable Rowboat Motor gas tank if one gets over-zealous with the application of heat around the

soldered seams. I'm not very good at soldering, but managed to get done what had to be done, which means there was some solder deposited in appropriate areas, but no explosions occurred and the local Fire Department's services were not required. Now it was on to the main body of the tank. There were no major cave-ins present on the various tank surfaces, but enough dips and dings were there that the use of some automotive body-filler was necessary. Took me about 6 hours of puttying,

drying, sanding, checking for low & high spots, refilling, re-sanding, rechecking, re-re-filling, yada yada yada. Finally had the result I could be happy with, so I masked the bronze cup part of the tank as well as the filler spout neck and hit it with the primer. Presto! Porosity City. More potholes than a Sudbury sidestreet. It's amazing how many microscopic pinholes will show up in your filler after you put the primer on. My eyesight must really suck when it comes to examining sanded filler, it sure LOOKED flat when the sanding was done and I blew off the surfaces with air. Oh well, guess that's why the Bondo folks also sell spot putty. More putty, more sanding, more inspection, more pinholes, more putty spots, more sanding, more inspection, more sanding, more sanding, and more sanding. That's enough, I've had it. Don't care anymore. Paint the damn thing and get it over with. Jeez! Time to invoke the "Scratch Motto"!

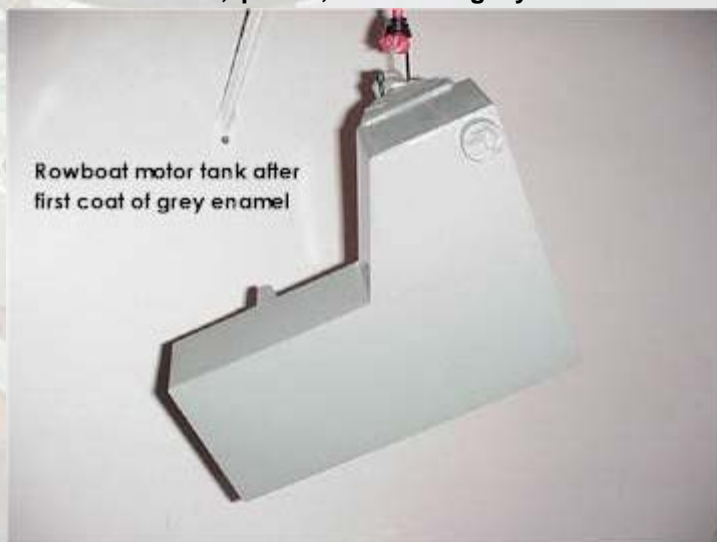
Rowboat motor tank after first coat of grey enamel

The primer was applied for the final time, light sanding done on the dry primer, then the top coat(s) of Armor-Coat enamel applied. The best tank I've ever done, period, even though you can still see pinholes on some surfaces. The tag will cover some of it, and most of the rest will be underneath the flywheel. Also the last tank I'll ever do. I quit. Can anybody tell me why bugs are so attracted to fresh paint? That's what I get for attempting to let it dry in the garage. I finally gave up trying to dry it in the garage, and proceeded to put the fresh-painted tank in my "motor room" closet to dry. I didn't care what the room smelled like while the paint was curing just as long as the aphids & gnats stayed somewhere else.
