# RESTORING AN ANCIENT EVINRUDE

## Chapter 3 – Gear-foot Reclamation

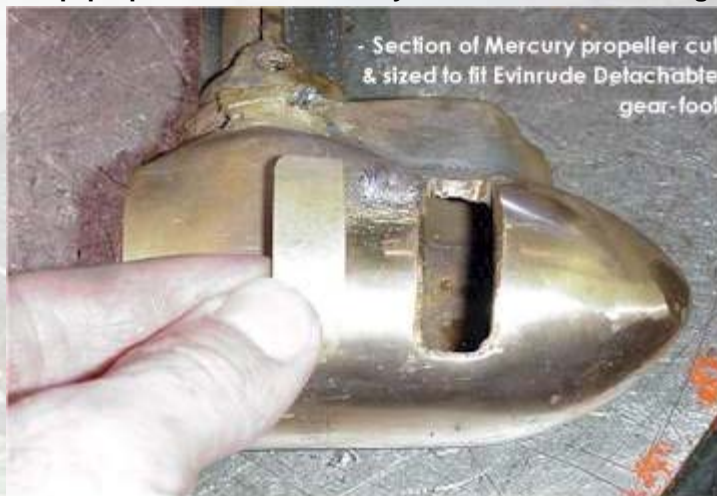
working with; it turned out to be a old beat-up propeller from a Mercury Mark 55. It had the right thickness, and even close to the correct curvature for this application, so a resection of prop blade was performed. After using a belt-sander to size and fit the repair piece, it was off to the welding station. Oxy-acetylene torches were used. I understand that a person can tig-weld brass, but I don't have a tig-welder at my disposal that I know how to use, and anyway, this is an antique motor, so the thought was that an antique process should be used to restore it. I also figure that with oxy-acetylene torches, I can weld a pop bottle to the sidewalk if I put my mind to it. It took about 10 minutes to heat things up to the point where I was

satisfied with the puddle formation, and so the weld repair proceeded. Fortunately, the torch did not "pop" on me, thereby sparing the frustration of having a weld puddle spatter all over the place with the resulting gross porosity that almost always is the end result of such an event. When the welding was finished, the part was allowed to air-cool until it could be safely handled, then the excess brass was sanded off using the belt sander to the point that a hand-grinder could finish the rough profiling. The hand-grinder was followed by wet-sanding with 600 grit paper, then the repair site was surveyed, and a decision made to further attempt to fix up some of the pinholes in the weld. The second welding attempt would be the last, one way or another. Well, maybe NOT the last; maybe just the second of many. I suppose I was being too fussy, and ended up doing a lot more remedial welding and grinding than was originally planned to plug pinholes that kept popping open, but finally got a result that was considered as acceptable.

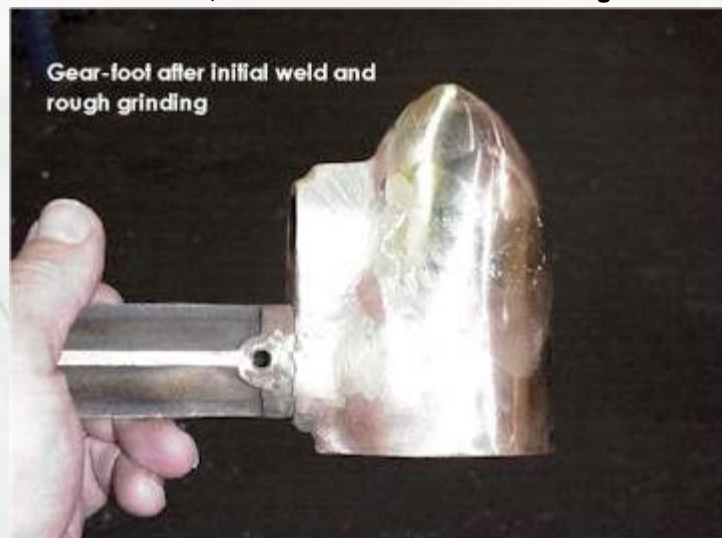
With the final weld, grind, sand and polishing of the gear-foot completed, it could be re-assembled for once and for all. I guess in retrospect I got really lucky (again) with the repair of this lower unit; if I'd had to do it over, I would have done the welding BEFORE I did the work of machining and installing

the bushings into the housing. It never occurred to me that applying heat with the torch might possibly cause some distortion in the housing until one of the guys in the maintenance department at the plant asked me about if it could happen or not. Well, no sense worrying about it after the fact, might as well carry on and see what result we had. With all the components installed, and packed full of fresh grease, I attempted to rotate the shaft by hand. It did rotate, but with some resistance, so some further inspection of the shaft alignment took place. Nothing seemed out of the ordinary, so I chucked the drive shaft in the mill and turned it on. The resistance rapidly decreased as the

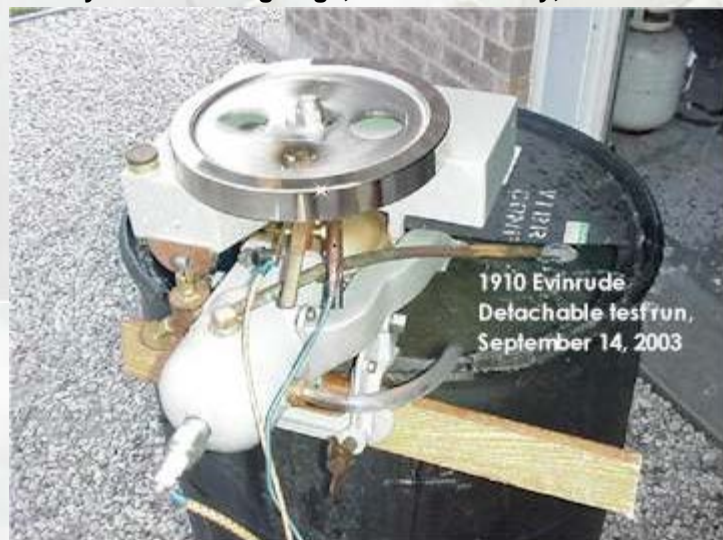
motor got clamped onto the tank. I poured about 2 cups of 8:1 mix into the tank, hooked up my battery and buzz-coil, opened the needle valve about  $\frac{3}{4}$  of a turn, bounce back and forth a few times to prime it, turn on the juice, bounce against compression, and POW!!! It fired once or twice, then quit. Now, what did that Chilton's manual say about starting these motors? Let me think for a minute..... oh yes, "repeat if necessary", so the start sequence was repeated, with the same result. Checking the carb setting, I figured it wasn't getting enough fuel, so turned the valve out to about  $\frac{7}{8}$  of a turn, and try again. This time, no fire, no pop. Hmmm..... maybe I went the wrong way with the needle, so its back in to the closed position, bounce the wheel, bounce the wheel again, bounce it a third time which gets the motor running for about 3 seconds. OK, I was flooding it, I forgot how sensitive these old mixing valves can be. Setting it at  $\frac{1}{2}$  turn out, primed and bounced again, with the result being that this time the motor took off and ran as one would expect it should. It made quite a racket, running with the open exhaust and with the sound reverberating throughout the garage. The motor was actually outside the garage, in the driveway, but the sound snuck in through the open doorway just

the same. Her bark sounded like a serenade from a firing squad, she smoked like trailer-park trash in a bingo parlour, and she did an admirable job of pumping a fair amount of cooling water out of the cylinder and onto the crushed stone, but she ran like a champ for a good two or three minutes. After reveling in the success of the starting and overall quality of the running of the motor, I realized that it was quite possible that the neighbours might not appreciate this as the historic event in marine history that any collector might deem it to be, nor share in my enthusiasm in the revival of some ancient aquatic iron; so, after snapping a couple of digital pictures for posterity's sake, the
